Mobile Intel® Celeron® Processor on .13 Micron Process in Micro-FCPGA Package

Specification Update

Document Number: 251309-009

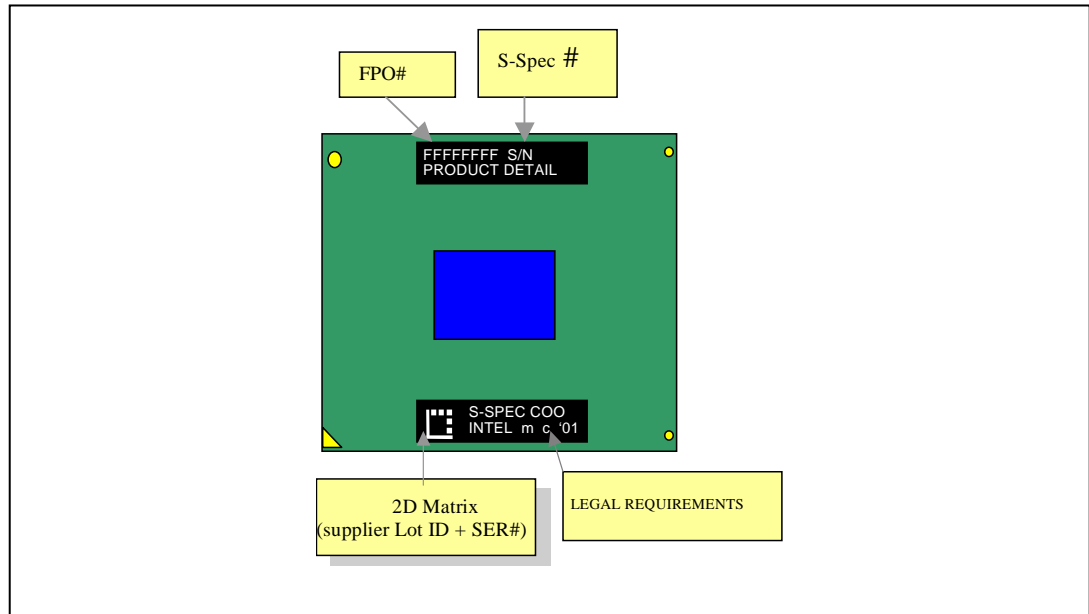
Figure 1. Mobile Intel® Celeron® Processor on .13 Micron Process (Micro-FCPGA) Markings
